Home Report

Scottish Single Survey

Property address	Cowal Farm Strachur Cairndow PA27 8DH
Customer	Mrs Mary Howatt's Executry
Customer address	Cowal Farm Strachur Cairndow PA27 8DH
Prepared by	Shepherd Chartered Surveyors
Date of inspection	29/10/2025

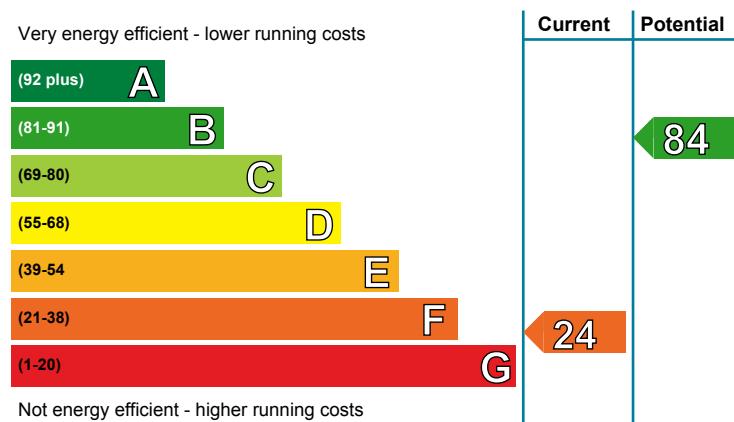
Energy Efficiency Rating

This graph shows the current efficiency of your home, taking into account both energy efficiency and fuel costs. The higher this rating, the lower your fuel bills are likely to be.

Your current rating is **band F (24)**. The average rating for EPCs in Scotland is **band D (61)**.

The potential rating shows the effect of undertaking all of the improvement measures listed within your recommendations report.

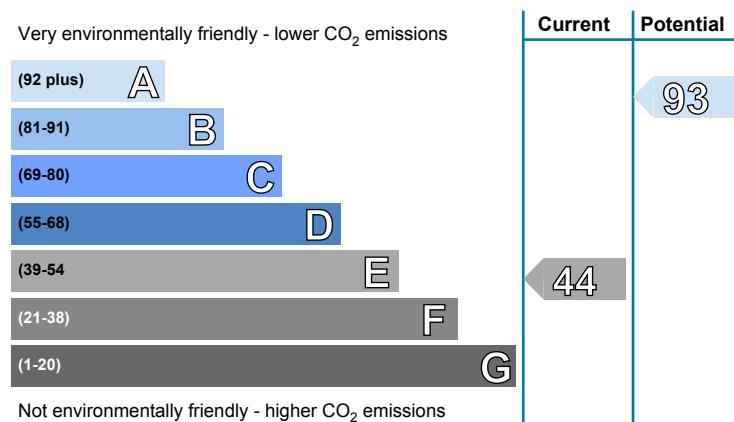
Environmental Impact (CO₂) Rating

This graph shows the effect of your home on the environment in terms of carbon dioxide (CO₂) emissions. The higher the rating, the less impact it has on the environment.
